NEW HAMPSHIRE DIVISION OF HISTORICAL RESOURCES

REPORT ON OBSERVATIONS AT THE BATH VILLAGE BRIDGE BATH, NEW HAMPSHIRE

JAMES L. GARVIN
SEPTEMBER 18, 2008

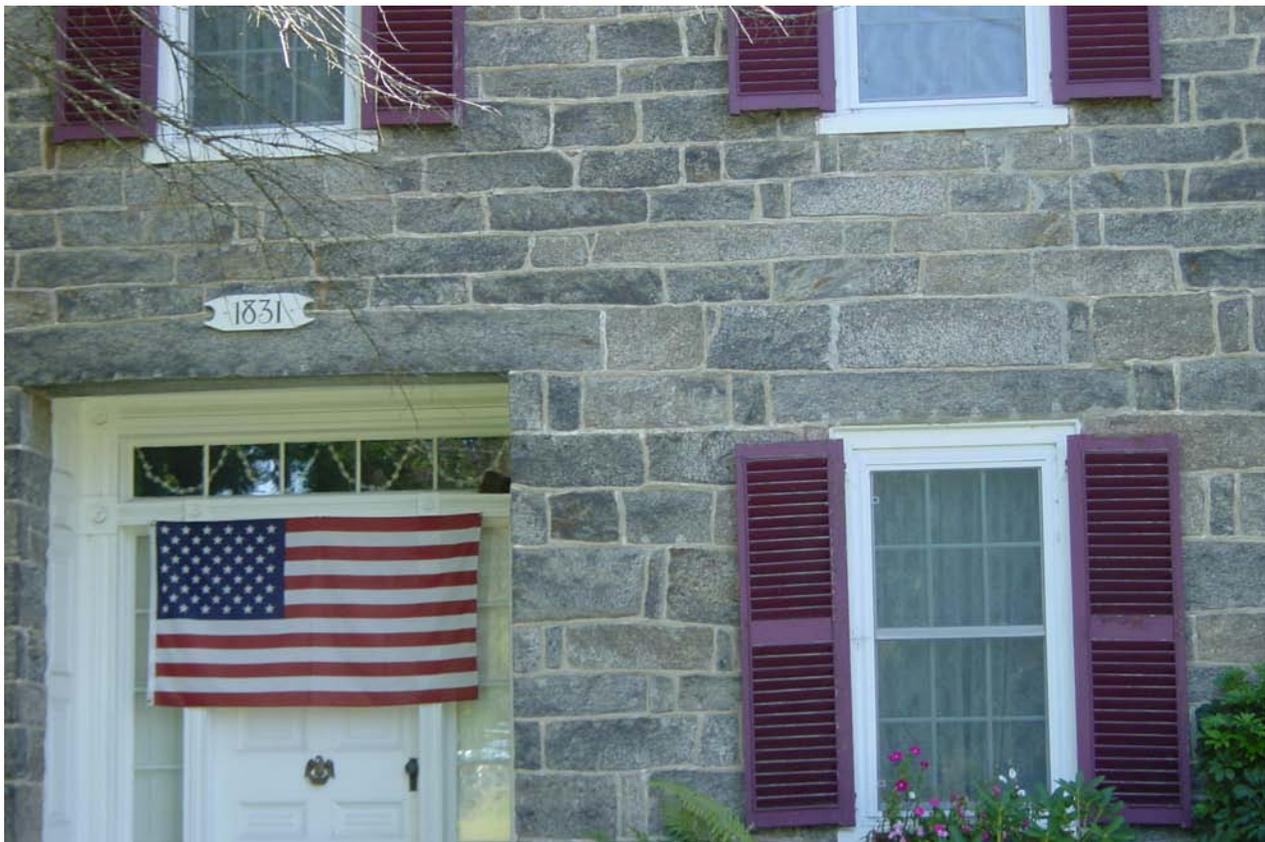
The fact that flat-wedge granite splitting was still being used in Bath in 1831, the year in which the two original piers were built, is verified by the William Vance Hutchins House, a granite dwelling of 1831 that stands a short distance from the bridge. As seen above the doorway and window in the photograph below, the walls of this building clearly show evidence of flat-wedge splitting.

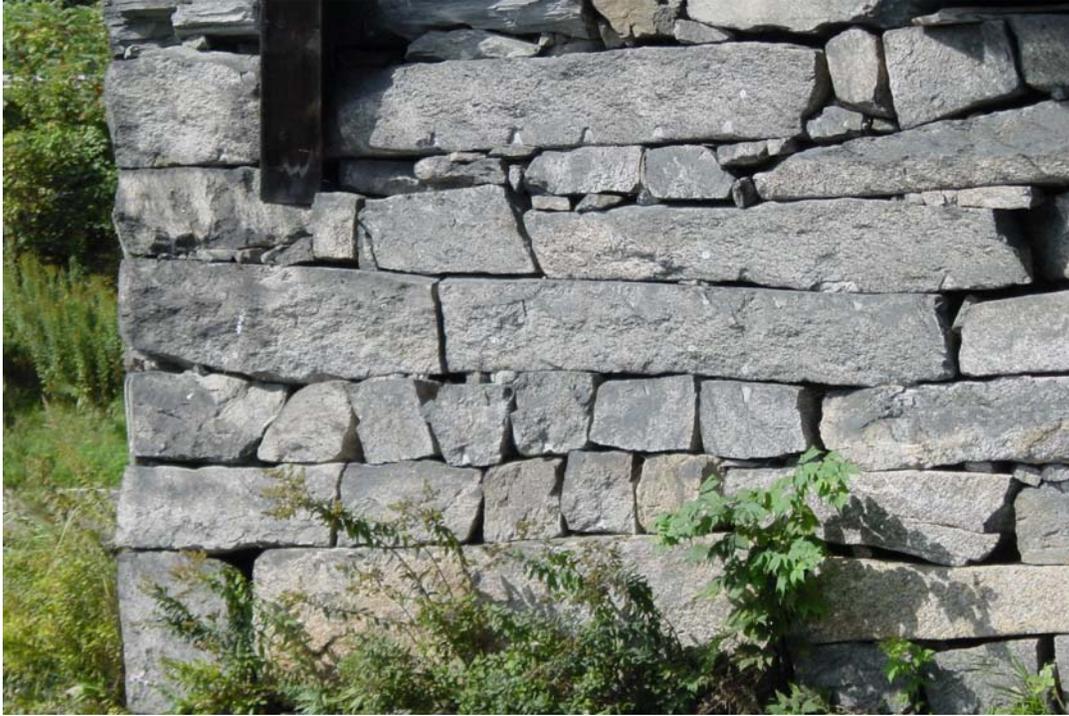
Detail of east face of Pier 2, Bath Village Bridge

The same splitting technique is clearly visible in both Pier 1 and Pier 2 of the Bath Village Bridge.

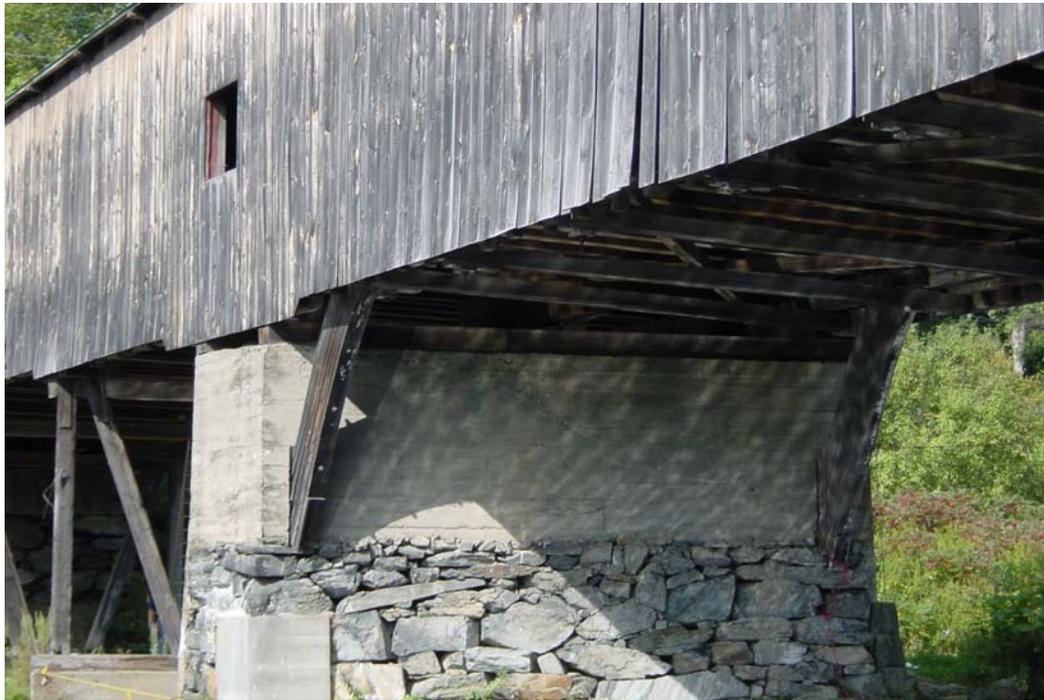
East face of Pier 3, Bath Village Bridge

By contrast, Pier 3 has fewer large split stones than Piers 1 and 2:

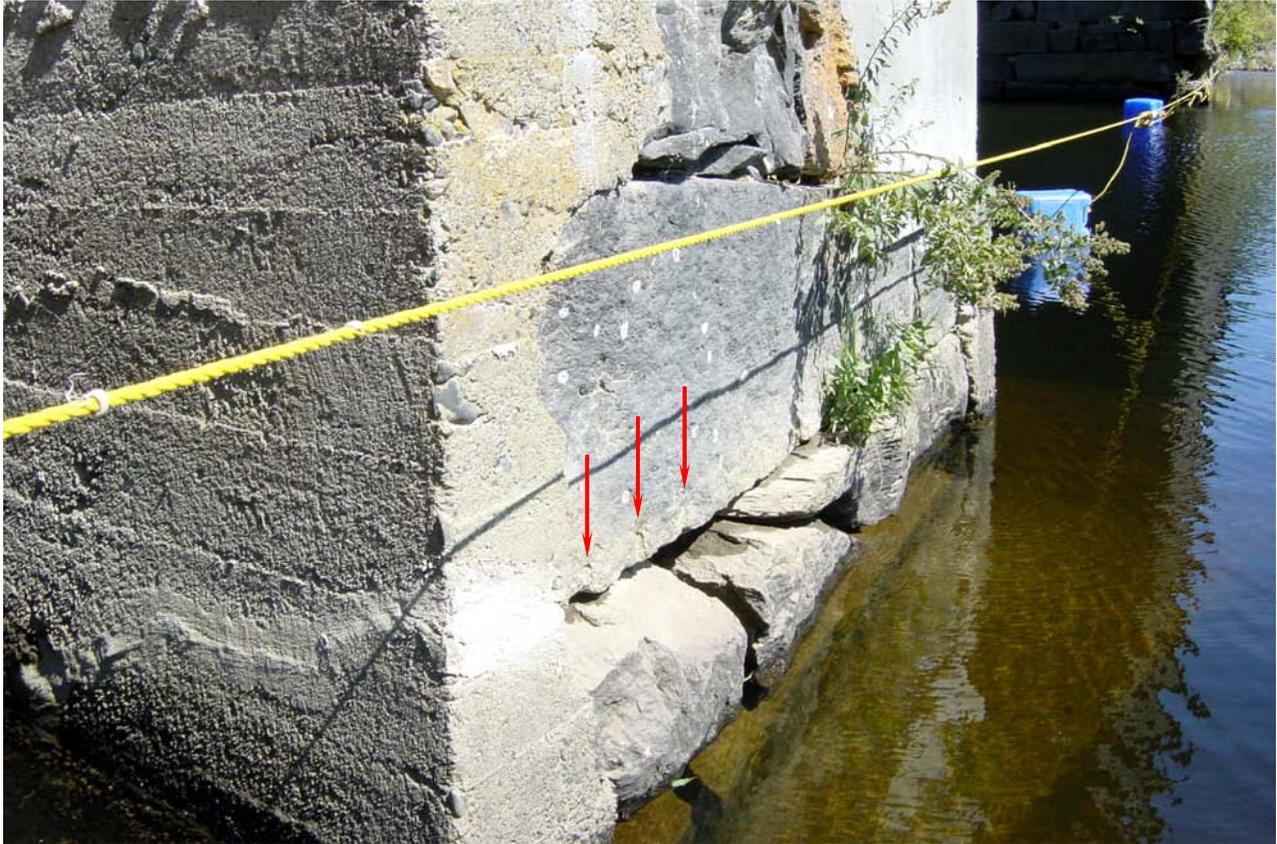
South face of Pier 3, Bath Village Bridge

While Pier 3 shows less evidence of splitting techniques, one of the lowest stones in this pier, clearly original, displays the marks of the plug drill, denoting its later date:

Although stone splitting evidence confirms the long-held belief that Pier 3 was added beneath the center of Span 3 after completion of the bridge, this physical evidence cannot suggest how much later the pier was added. Because the flat-wedge method of splitting granite was supplanted by the plug-and-feathers method soon after the bridge was built, Pier 3 could date anywhere from a few years after completion of the span up to around 1910, when concrete supplanted stone masonry for most work. Although the stonework of Pier 3 is too crude to suggest railroad construction of the latter nineteenth century, it is possible that this pier was added to the bridge when tracks first passed under the bridge in 1852-3. It is possible that this pier was not originally built to the height of the others, but that it supported a wooden trestle that extended up to the bottom chords of the bridge.

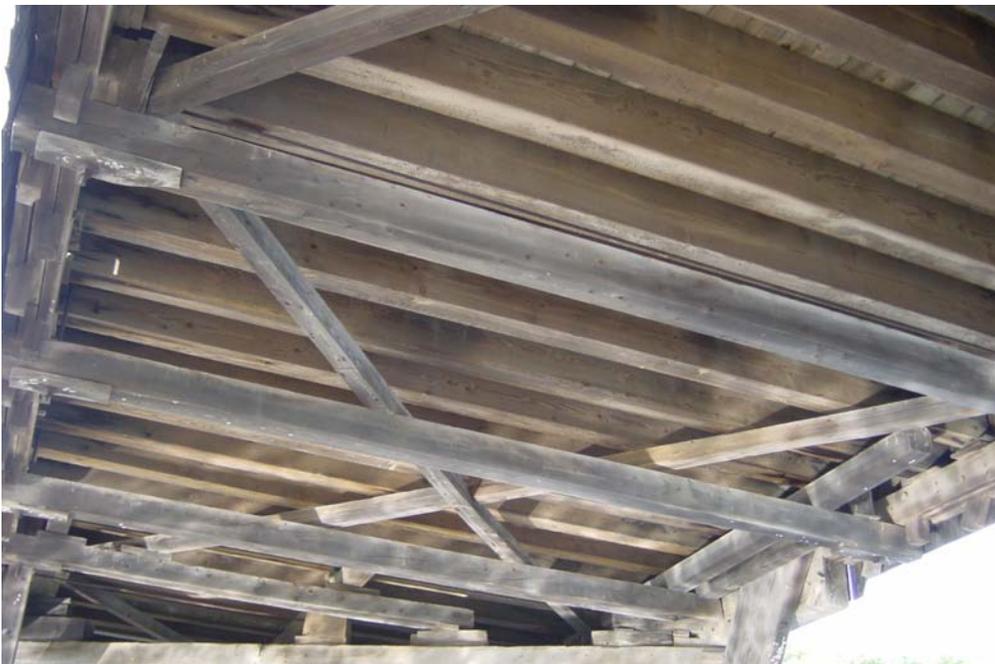
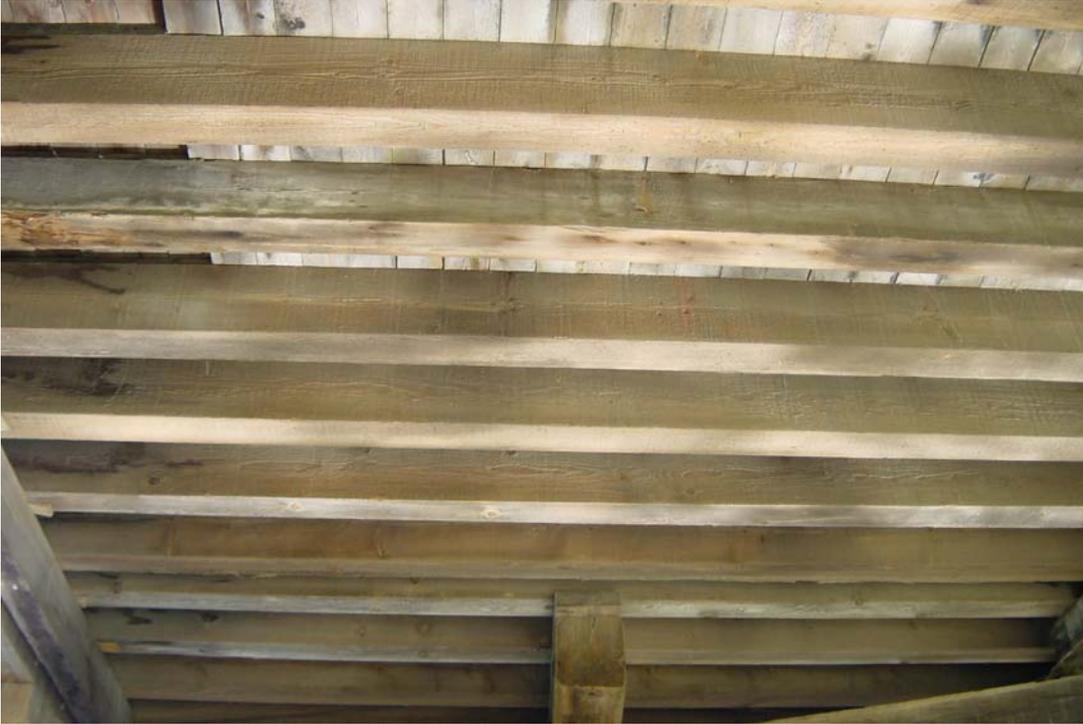
Observations made from the available vantage points suggest that all of the floor beams now in the bridge are of recent date. Some existing beams appear to predate the rehabilitation of 1987-88. Those beams that were found to be sound in 1987-88 appear to have been turned over to allow new floor planking to be nailed into the sound wood of what had been the bottoms of the beams.

The majority of beams now seen in the bridge, however, appear to have been installed in 1987-88 above older needle beams and lower lateral bracing:

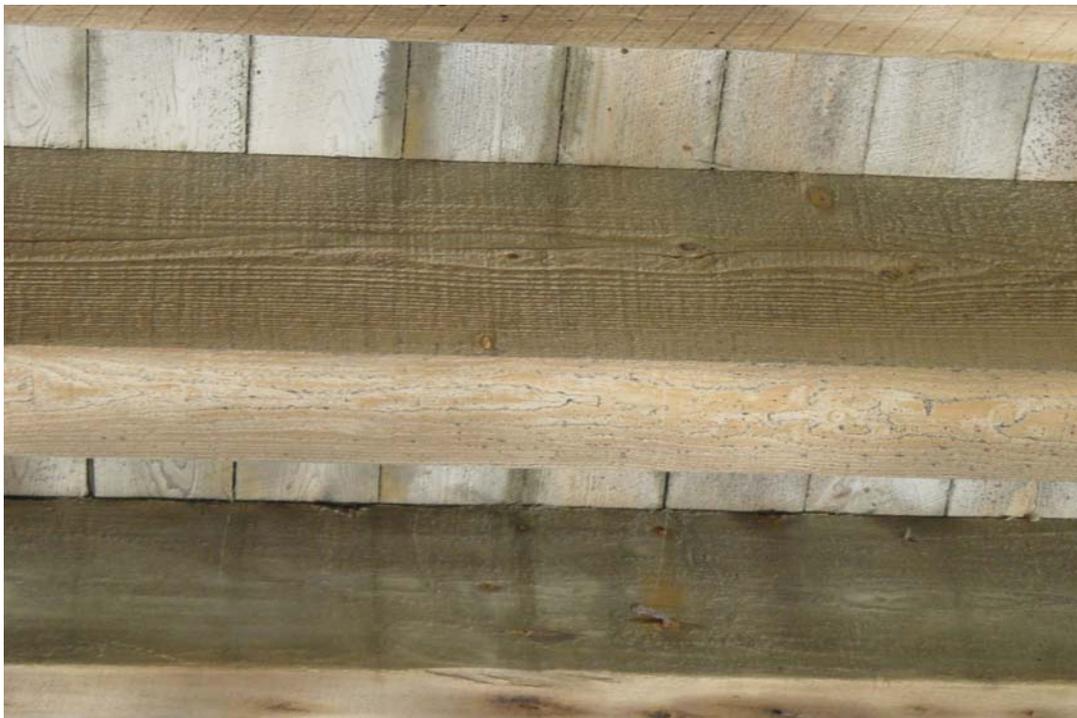
The new floor beams of 1987-88 appear to have been band-sawn on their sides, and cut to depth on a circular sawmill, leaving curved saw marks on their soffits, as seen below:

Bottom: re-used floor beam. Middle and top: band-sawn floor beams sawn to depth on a circular saw
