NEW HAMPSHIRE DIVISION OF HISTORICAL RESOURCES

REPORT ON OBSERVATIONS AT THE BATH VILLAGE BRIDGE BATH, NEW HAMPSHIRE

JAMES L. GARVIN
SEPTEMBER 18, 2008

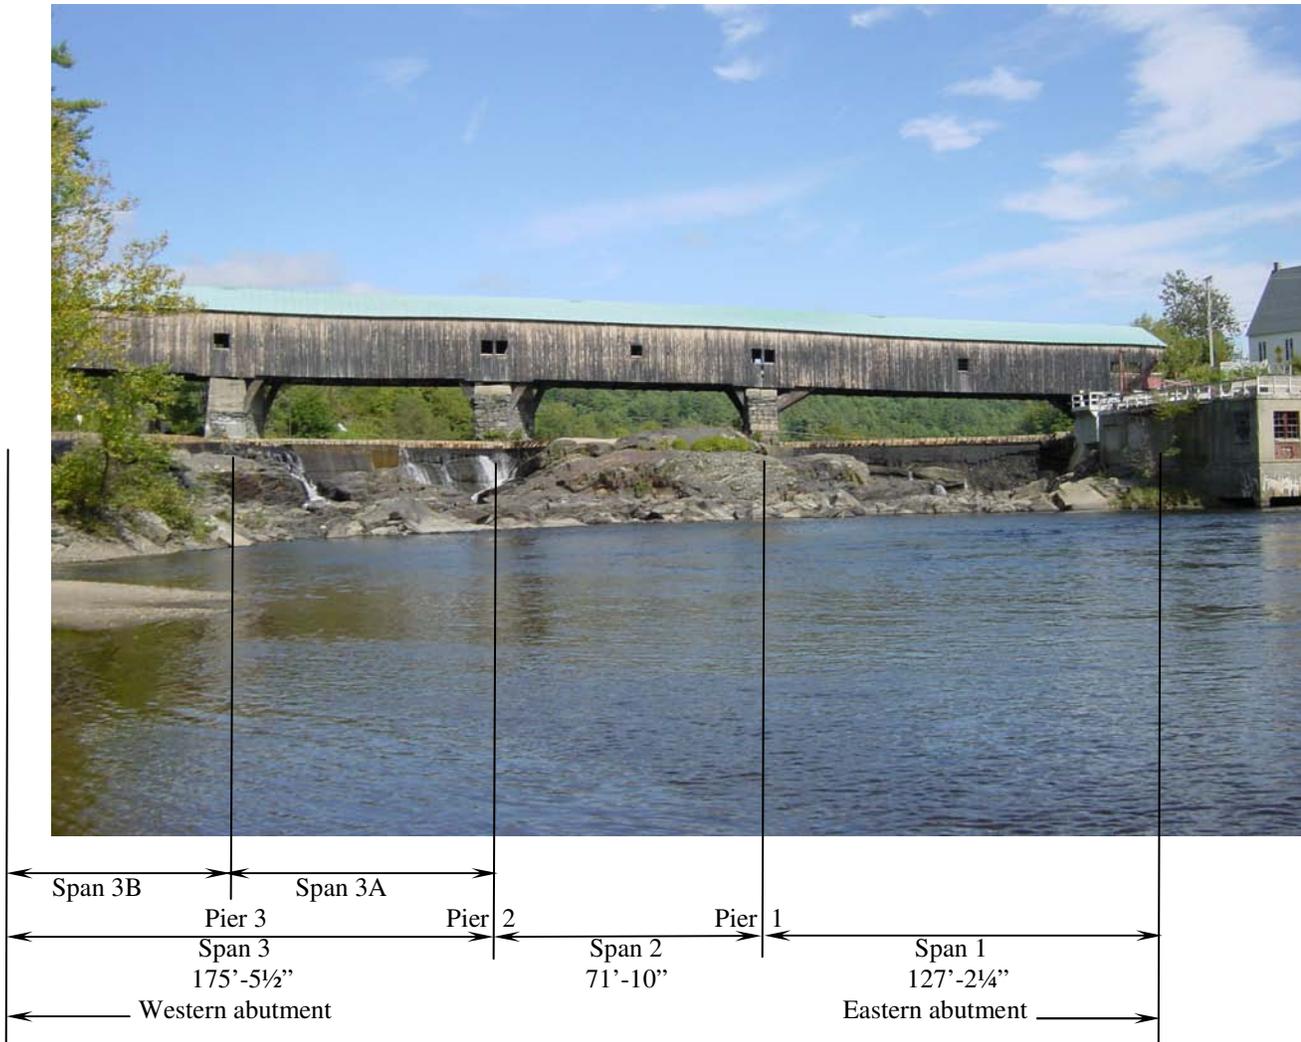
The Bath Village Bridge is composed of three original spans of widely varying lengths. The bridge has apparently not been measured along its centerline, and the different angles of the abutments and the piers causes the upstream and downstream trusses in each span to display differing lengths. The HAER report mentioned above gives the total truss length of Bath Village Bridge as 374'-5¾" at the floor. The length of the east span is 127'-2¼" on the upstream side. The center span is 71'-10" in length, while the long original west span (now subdivided by an added pier at its center) was 175'-5½" long.

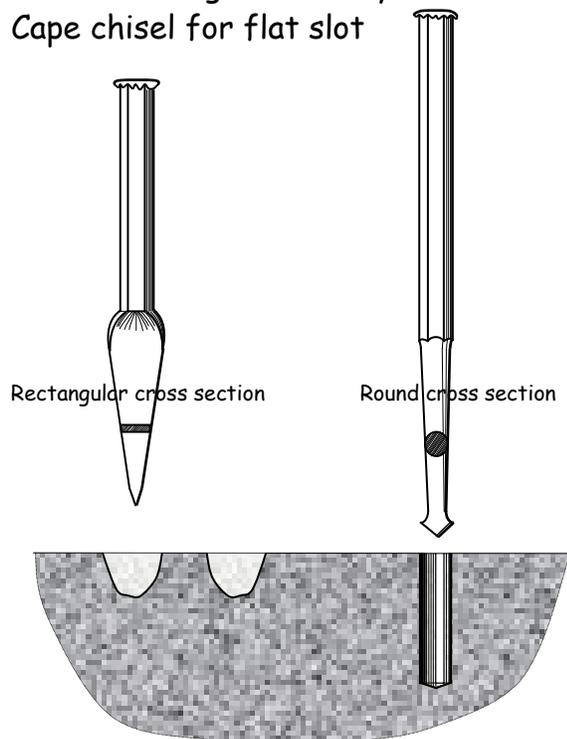
Plug drill for cylindrical hole
Cape chisel for flat slot

Prior to about 1830, the procedure for splitting granite entailed the cutting of a line of shallow slots in the face of the stone, using a tool called a cape chisel, struck with a heavy hammer. Small, flat steel wedges were placed between shims of sheet iron and driven into these slots, splitting the stone. The new splitting method of circa 1830 used a “plug drill,” which had a V-shaped point and was rotated slightly between each blow of the hammer, creating a round hole two or three inches deep.

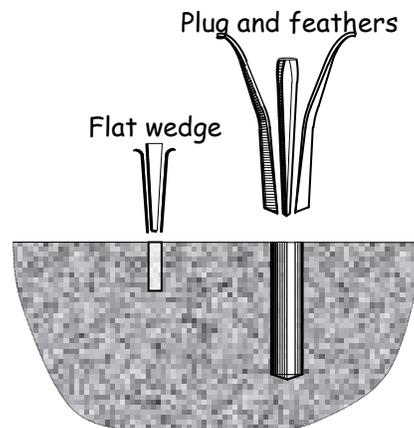
Into this hole were placed a pair of half-round steel shims or “feathers,” and between these was driven a wedge or “plug” which exerted outward pressure and split the stone. The advantage of the “plug-and-feathers” method of splitting was the greater depth within the stone at which the wedges exerted their pressure, thus allowing larger pieces to be split more accurately.

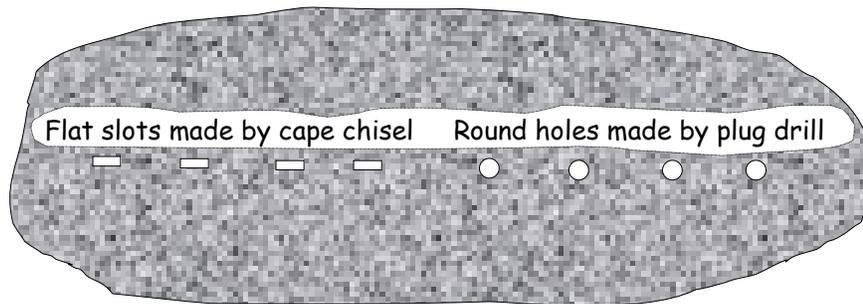
When seen on the surface of a stone that was prepared for splitting but never split, these slots or holes appear as shown below:
